Seismic performance of the temple of Aphaia in Aegina island, Greece

The seismic performance assessment of the ancient Temple of Aphaia in Aegina island, Greece, is presented. The Temple of Aphaia was erected around 500BC using porous limestone and is one of the most characteristic examples of Doric architecture. The assessment is performed within a performance-based framework using state-of-the-art tools of earthquake engineering. In the first part, the seismic hazard of the site was calculated using the European Seismic Hazard Model and hazard-consistent records were selected. Then, the Temple was scanned by drone and the point cloud was used to develop the numerical structural model. The Temple was analyzed using the discrete element method. Appropriate engineering demand parameters and limit state thresholds were defined. Fragility curves for the structural elements, namely, columns and architraves, of the Temple were computed via multi-stripe analysis. Finally, the seismic risk of the Temple was evaluated using long-term estimates in terms of return periods of exceeding limit states and total loss. The outcomes of the study offer valuable information to engineers, architects,

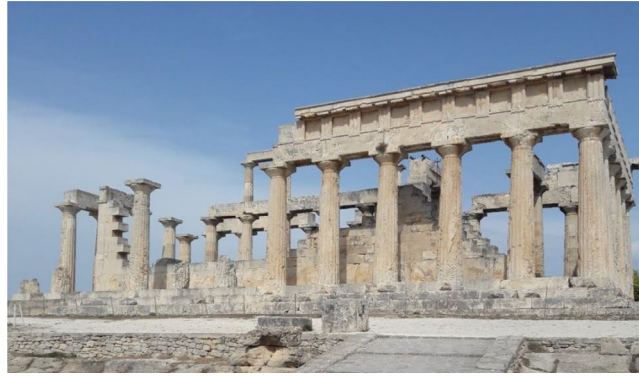
FIGURE 1 The Temple of Aphaia [courtesy of the authors and the Directorate of Restoration of Ancient Monuments, Ministry of Culture, Hellenic Republic].

The Temple of Aphaia (Figure 1) is considered one of the most important and well-preserved monuments of archaic architecture. The Temple is founded on a three-layered crepidoma (i.e., stone foundation) and consists of the Opisthodomos (posterior), the Cella (central), the Pronaos (anterior), and the external colonnade. It is a peripteral Doric order temple with 12 columns on the long side and 6 on the short side (corner columns are double-counted). The side views of the temple are shown in Figure 2. The dimensions of the stylobate (base) are 30.55 m × 15.50 m and the Cella is approximately 22.50 m long and 8.00 m wide. Initially the external colonnade of the temple consisted of six columns at the narrow sides and twelve on the wide. Nowadays, on the north and south side, nine and seven columns respectively can be found, while on the west side only three remain intact. On the east side of the temple all columns are still standing. The total height of the columns of the external colonnade is 5.30 m and the diameter at the base is 1.00 m. The columns

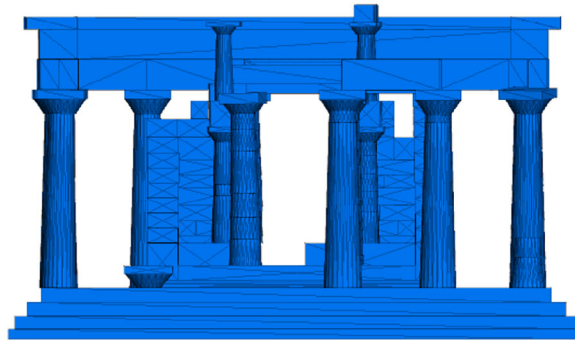
FIGURE 8 West view of the numerical model of the Temple of Aphaia.

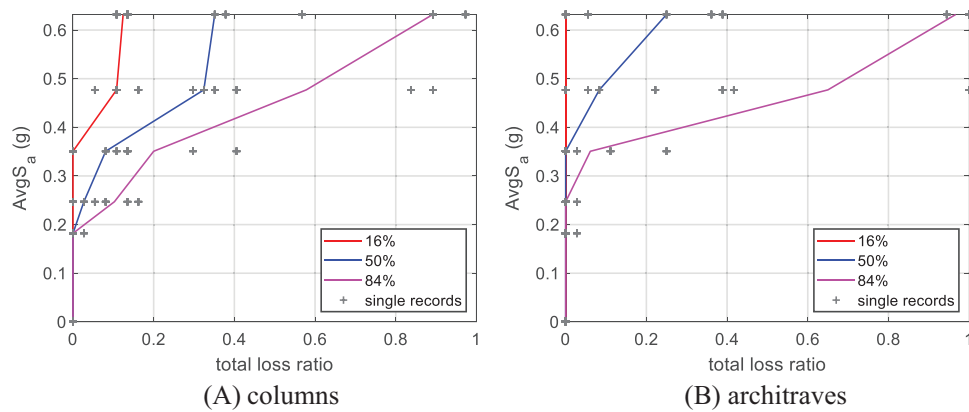
FIGURE 20 Total loss ratio per group of elements for the 5 × 11 ground motions employed and the corresponding 16/50/84% quantiles of total loss.

Moving a step further in long-term risk, the MAF of exceeding percentages of total loss per group of elements (columns, architraves) was assessed. This was performed at the level of the MSA results, working on a record-by-record case to calculate the percentage of elements of the same type (columns, architraves) that exceed LS3. The total loss ratios of the columns and architraves are shown in Figures 20A and B, respectively, for the total number of the 5×11 records considered. In Figure 20, the corresponding 16/50/84% quantiles of the total loss ratio per IM level are also presented. On average, the architraves are less seismically vulnerable than the columns since the median total loss ratio is lower than that of the columns for all $AvgS_a$ levels. On the other hand, the total loss for the architraves shows higher dispersion than that of the columns.

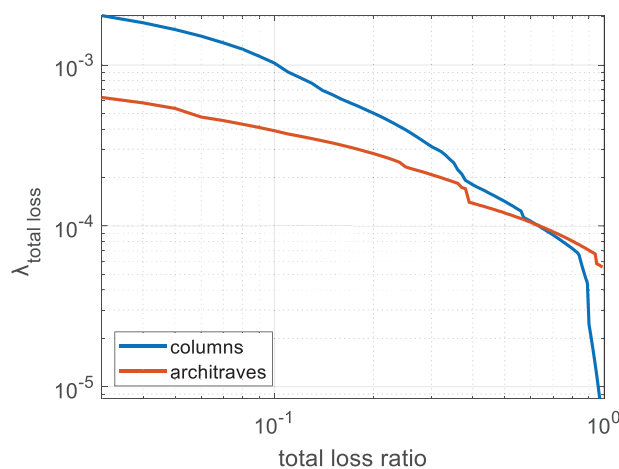
FIGURE 21 MAF of total loss for the columns and the architraves of the Temple.

Again, for the integration with the hazard, the lower limit of $AvgS_a = 0.001$ g was employed for the integration per Equation (8). Figure 21 presents the MAF of the total loss ratio ($\lambda_{total\ loss}$) via Equation (8) for the columns and the architraves of the Temple. These estimates offer valuable information for prioritizing short- and long-term restoration actions. For example, for a return period $T_r = 475$ years, matching the design return period for ordinary structures per

EN 1998-1:2004,⁴⁰ the total loss ratio is 3% for columns and 0% for architraves. Instead, for a return period $T_r = 4975$ years, or the design return period for high-importance structures, the total loss ratio increases to 37% for columns and 30% for architraves.
